Coastal Engineering Analysis

West Trail Shoreline Protection, Pillar Point Harbor, CA

Geotechnical Assessment

Pillar Point Harbor West Trail Erosion Repair

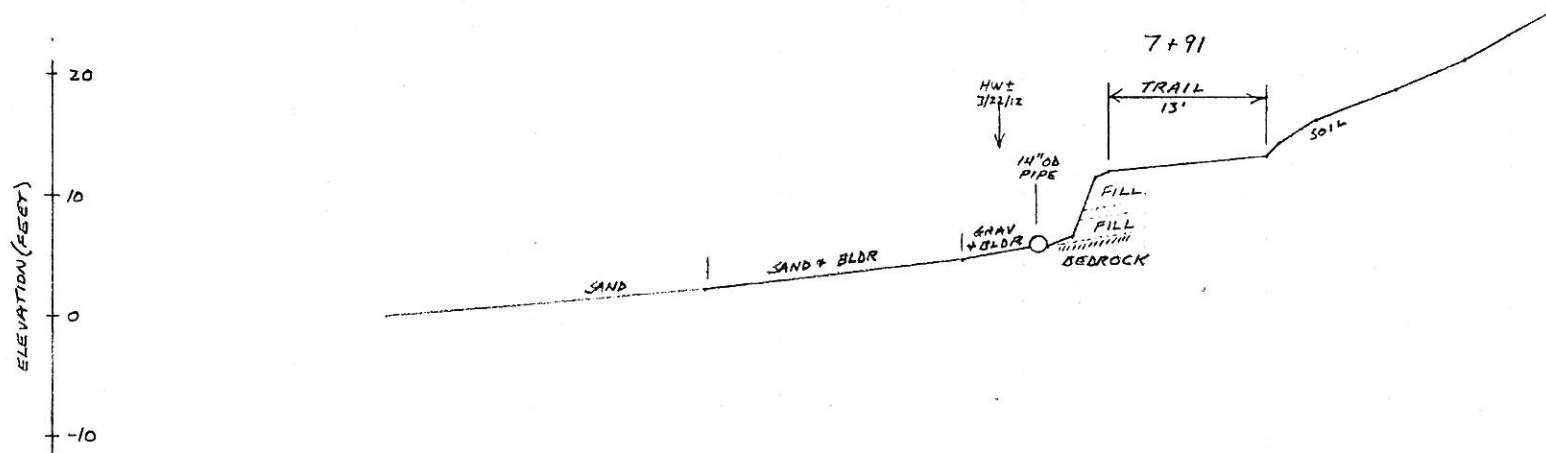
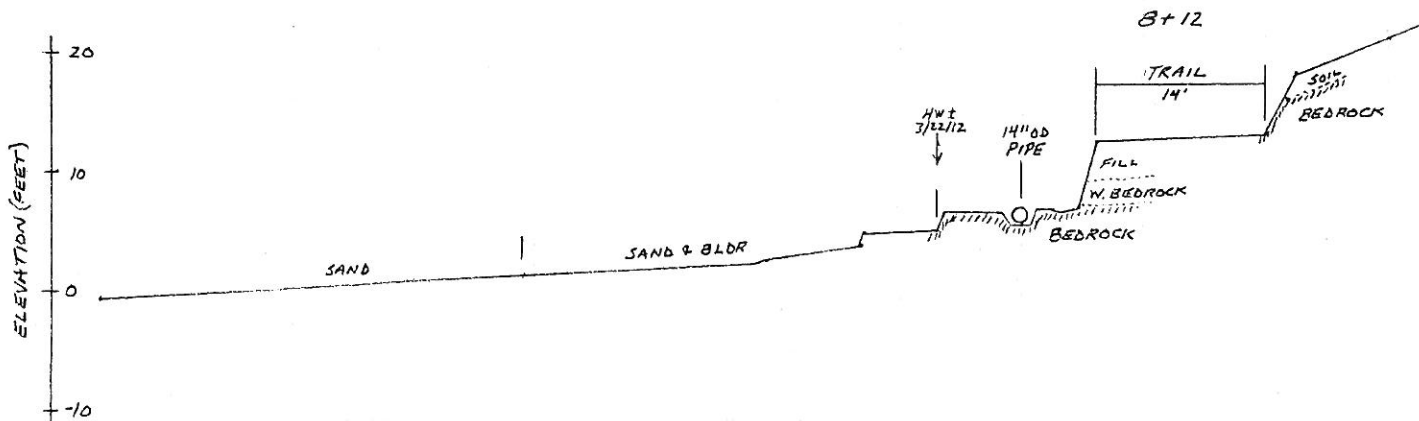
CROSS SECTIONS 7+91 AND 8+12

7+91 and 8+12 causes saturation of the materials underling the trail surface and rill erosion of the outer trail edge.

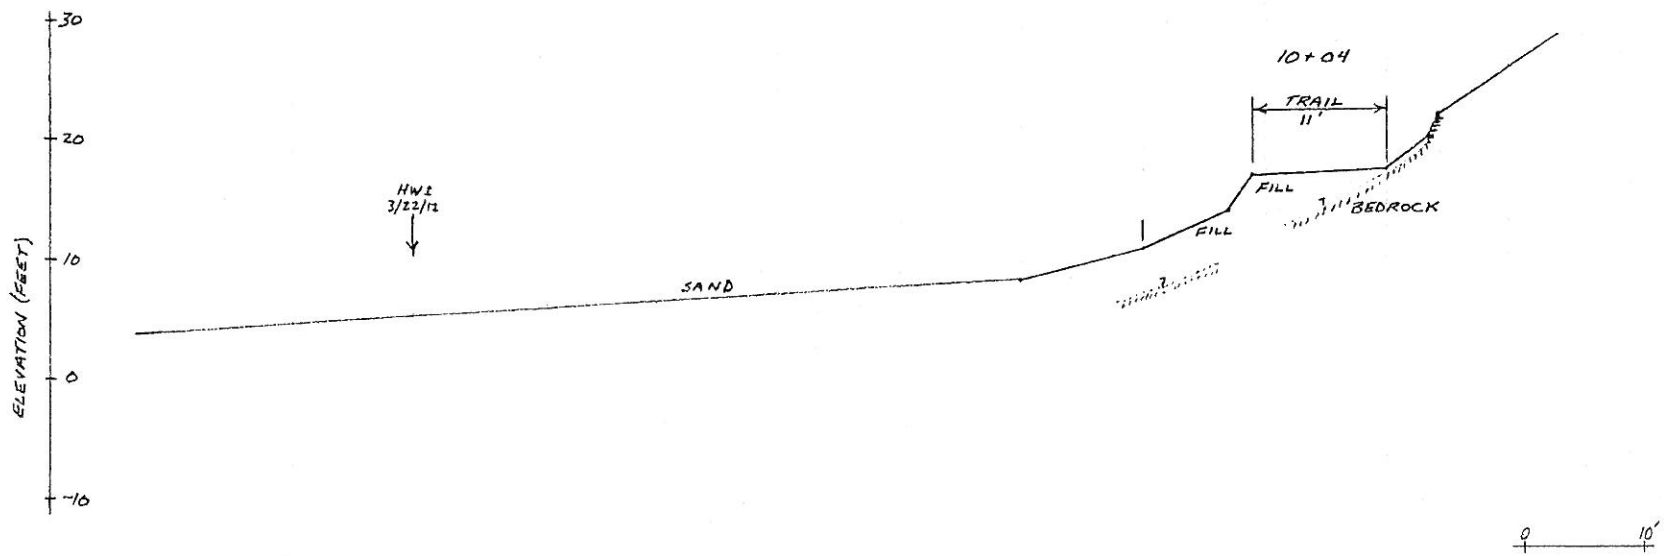
CROSS SECTION 10+04

Our observations of the earth materials exposed in the steep bank between stations 9+90 and 10+60 indicate that the outer edge of the trail is underlain by at least 4 feet of gravelly fill at this location. Friable bedrock was exposed at the base of the upslope cut and is expected to underlie the outer edge of the trail at depths ranging between 6 and 8 feet.
