Montara State Beach Shoreline Armoring

History
Permitting
Aesthetics
Maintenance & use life
Restoring public coastal views

by Lisa Ketcham, 2022

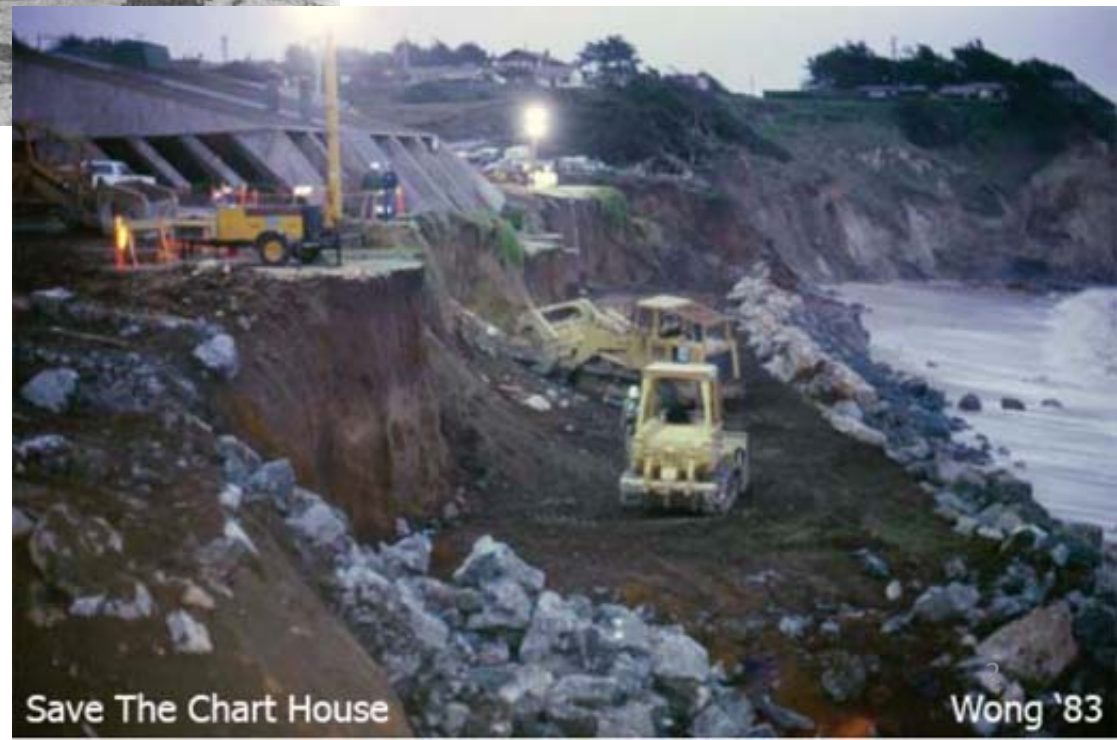
1983 El Niño storms –
Emergency armoring installed on
the public beach to protect
the Chart House restaurant,
only 4 years after construction.

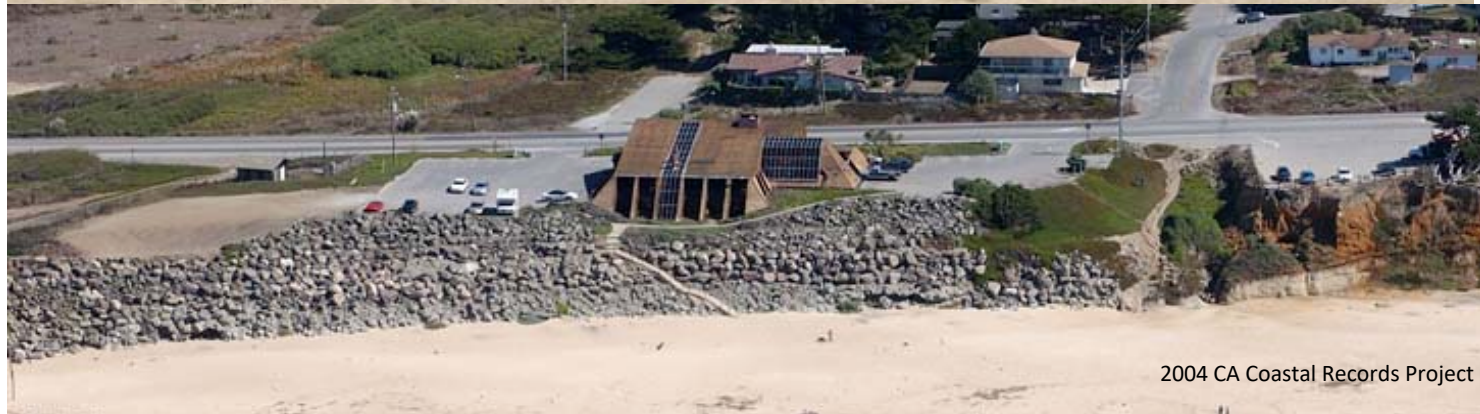
1979: newly constructed Chart House restaurant
(built on footprint of former 50's motel/restaurant)

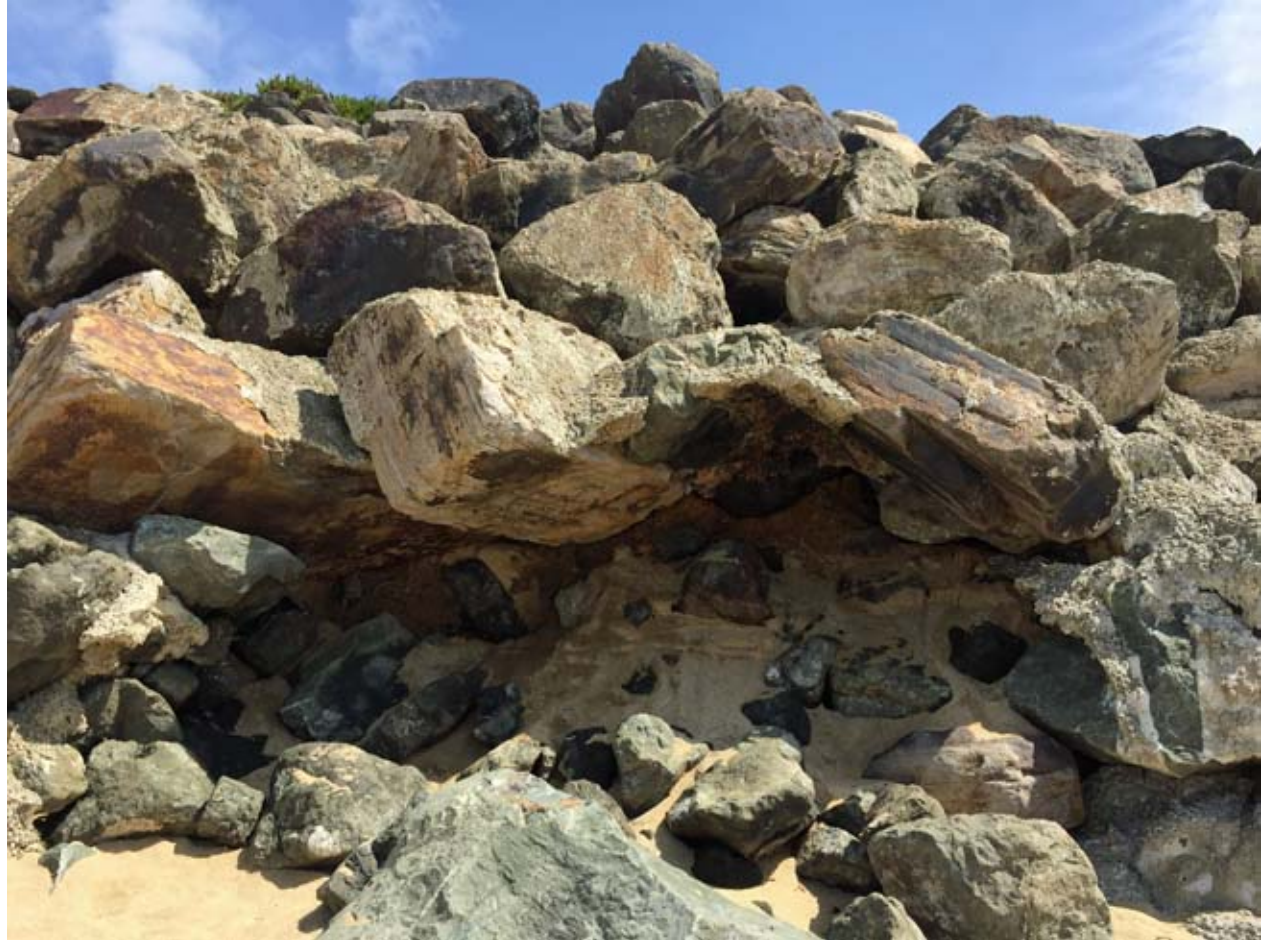
Steep wall of boulders
is 40 years old,
undermined and hazardous.

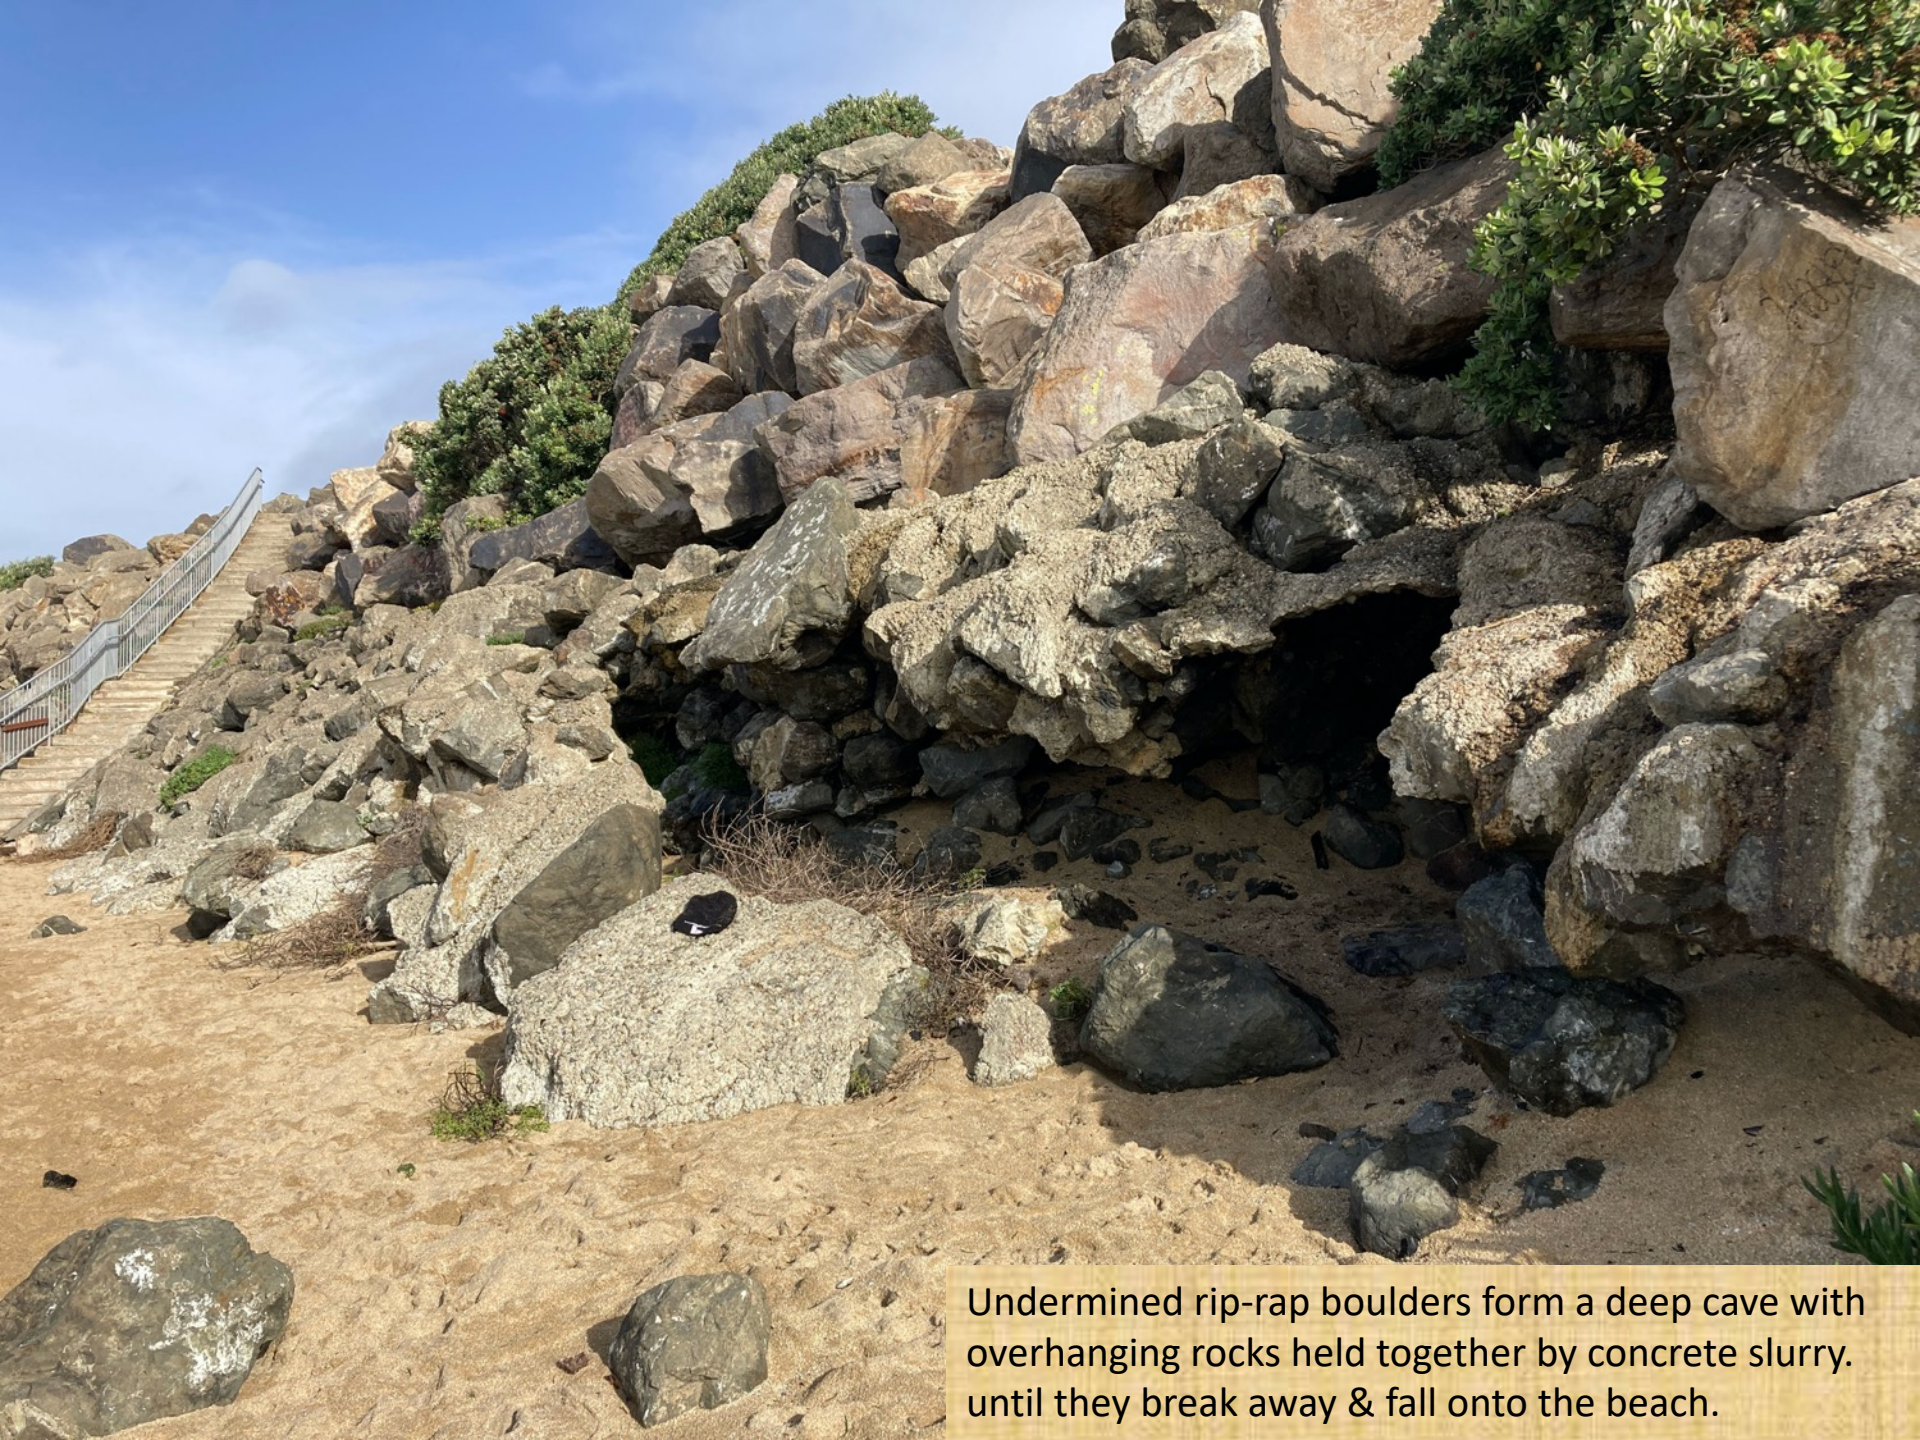
- The riprap was not keyed into the firm ground underlying the sand.
- The bottom 6 ft of the riprap has been grouted with cement.
- Both parking lots drain to outlet pipes that discharge behind the riprap, causing its undermining.
- The report includes recommendation for rerouting the drainage pipes and repairing the riprap sea wall.

Undermined rip-rap boulders form a deep cave with overhanging rocks held together by concrete slurry, until they break away & fall onto the beach.

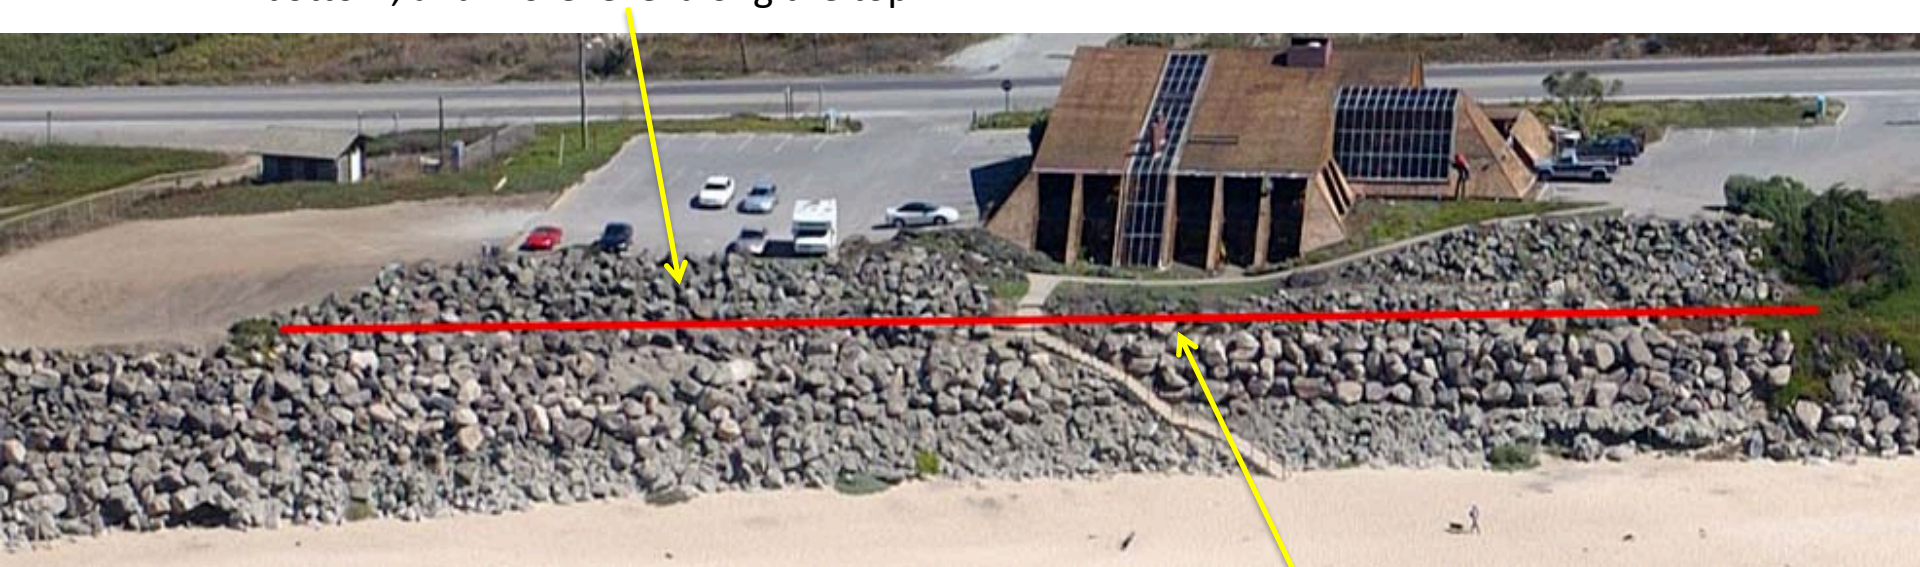
Rip-rap extends onto top of bluff, far beyond where needed for erosion protection, blocking public access and views. Plan cross-sections of the rip-rap are conceptual, showing an even, gentle slope, but in reality the slope is much steeper along the bottom, and more level along the top.

Red line marks the upper reach of rip-rap in front of the restaurant, and the dirt State Parks lot, which have no view obstruction.

Rip-rap repairs should include removal of view-blocking boulders on the bluff top.

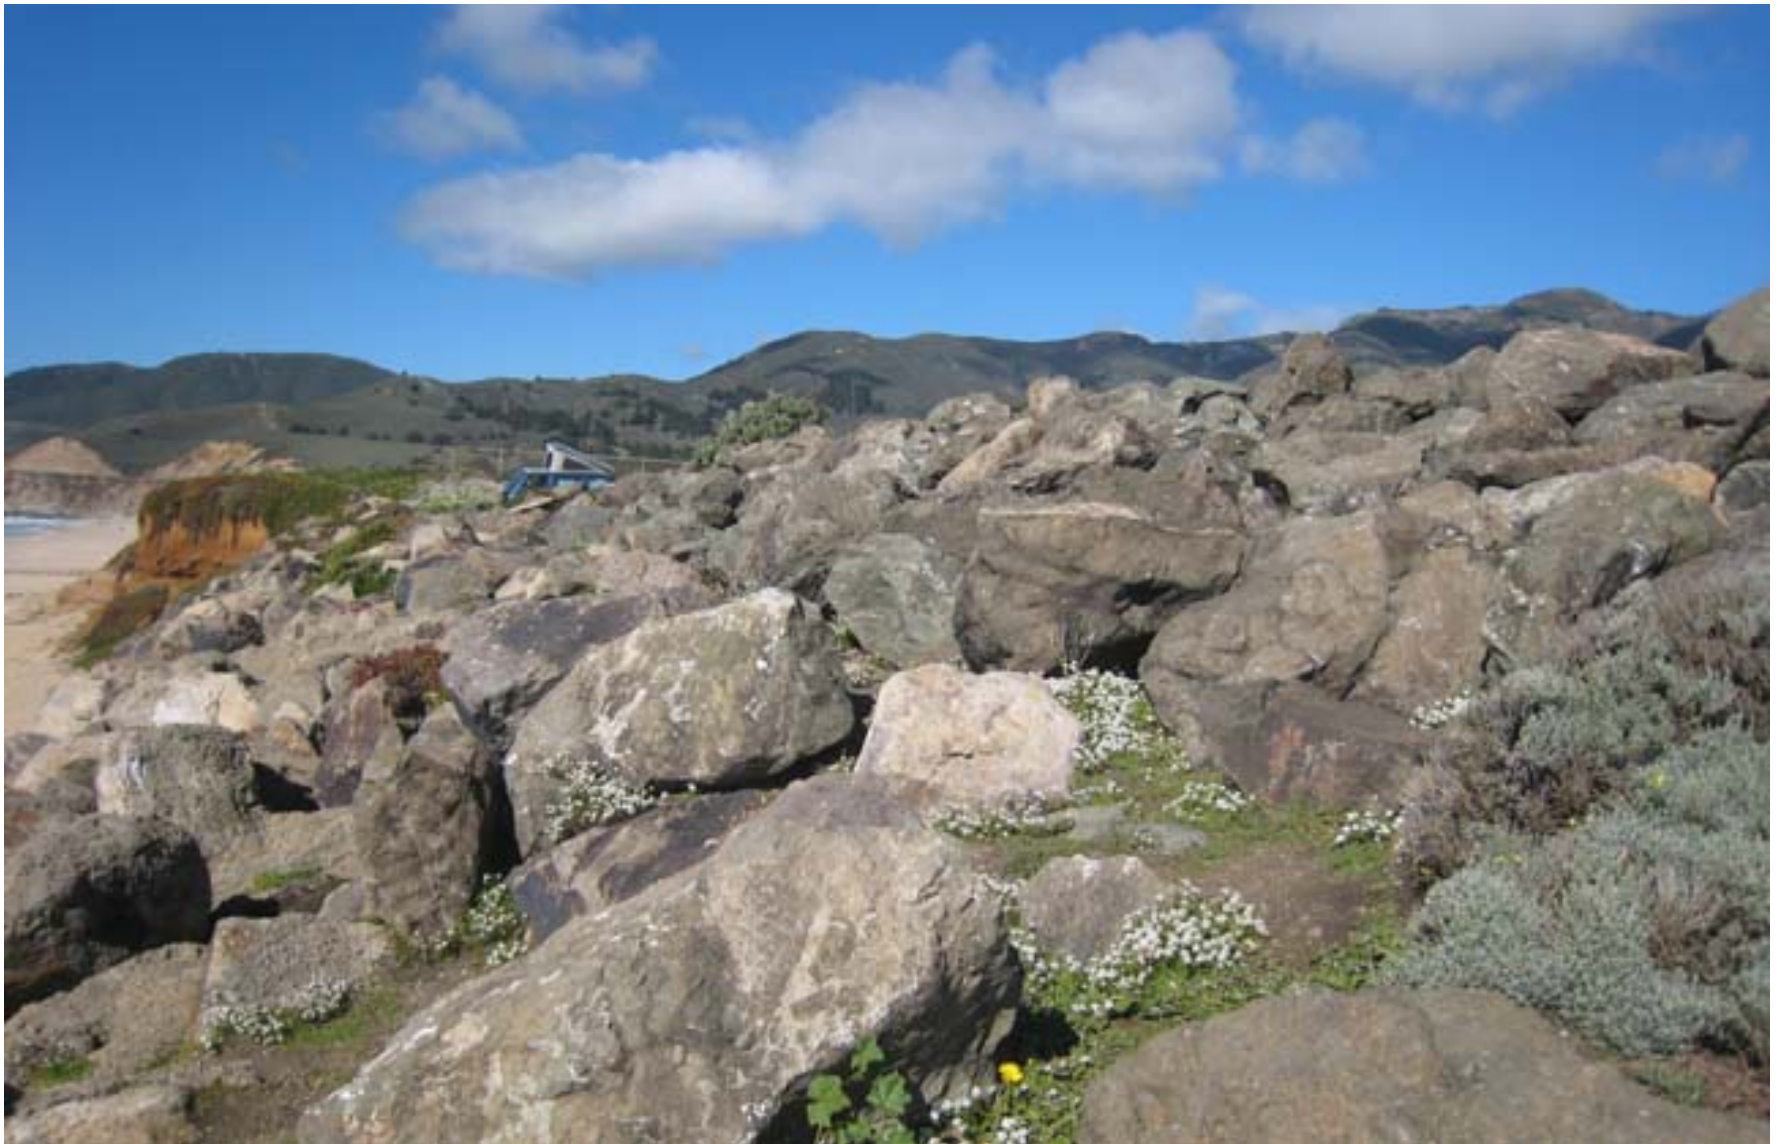
Excess alien boulders strewn over the blufftop, blocking access and marring the mountain view.

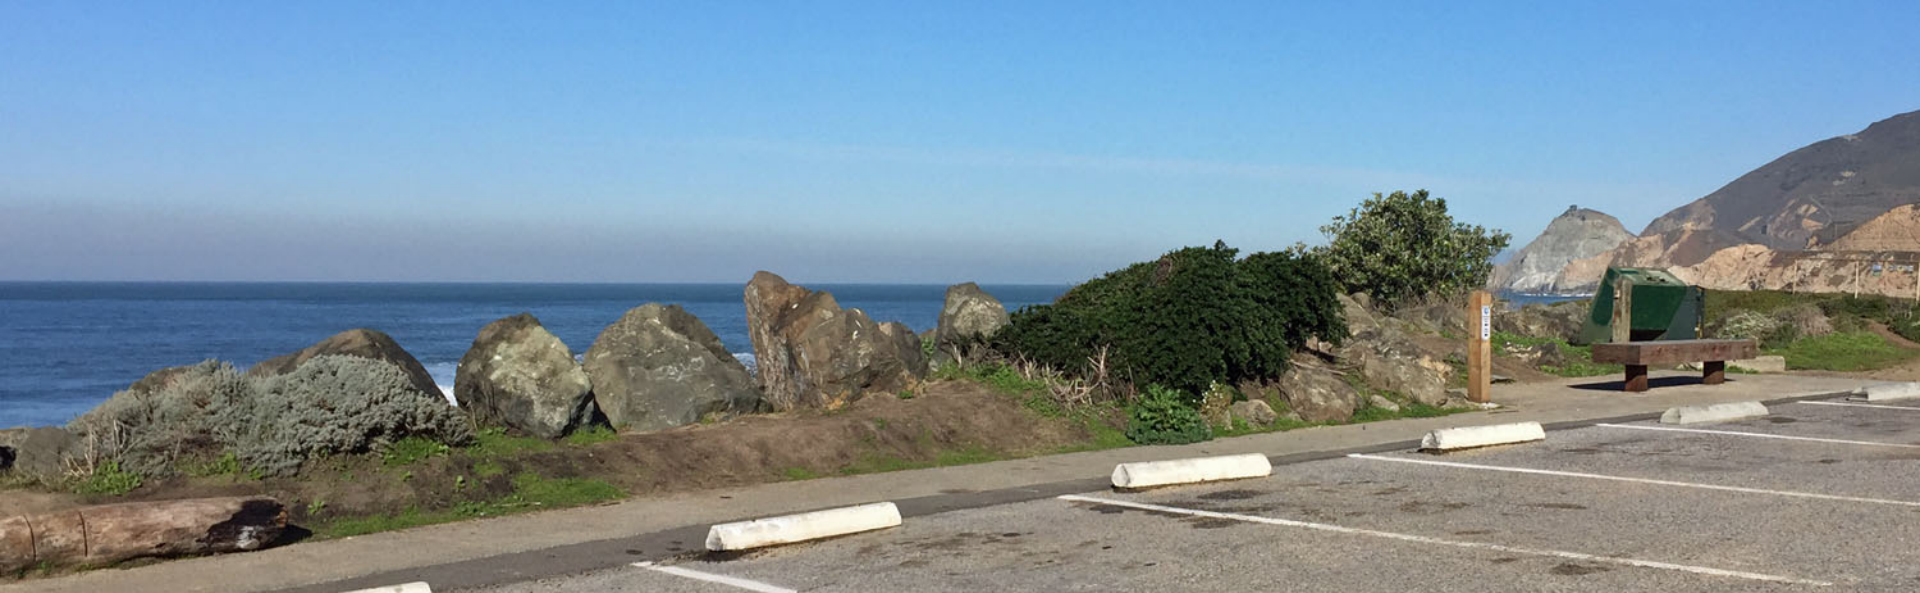
County did not require removal of excess boulders concurrent with CCC-mandated public access improvements (walkway extension and viewing benches).

View from bench --
Coastal Trail sign says
“Public Viewing Area”

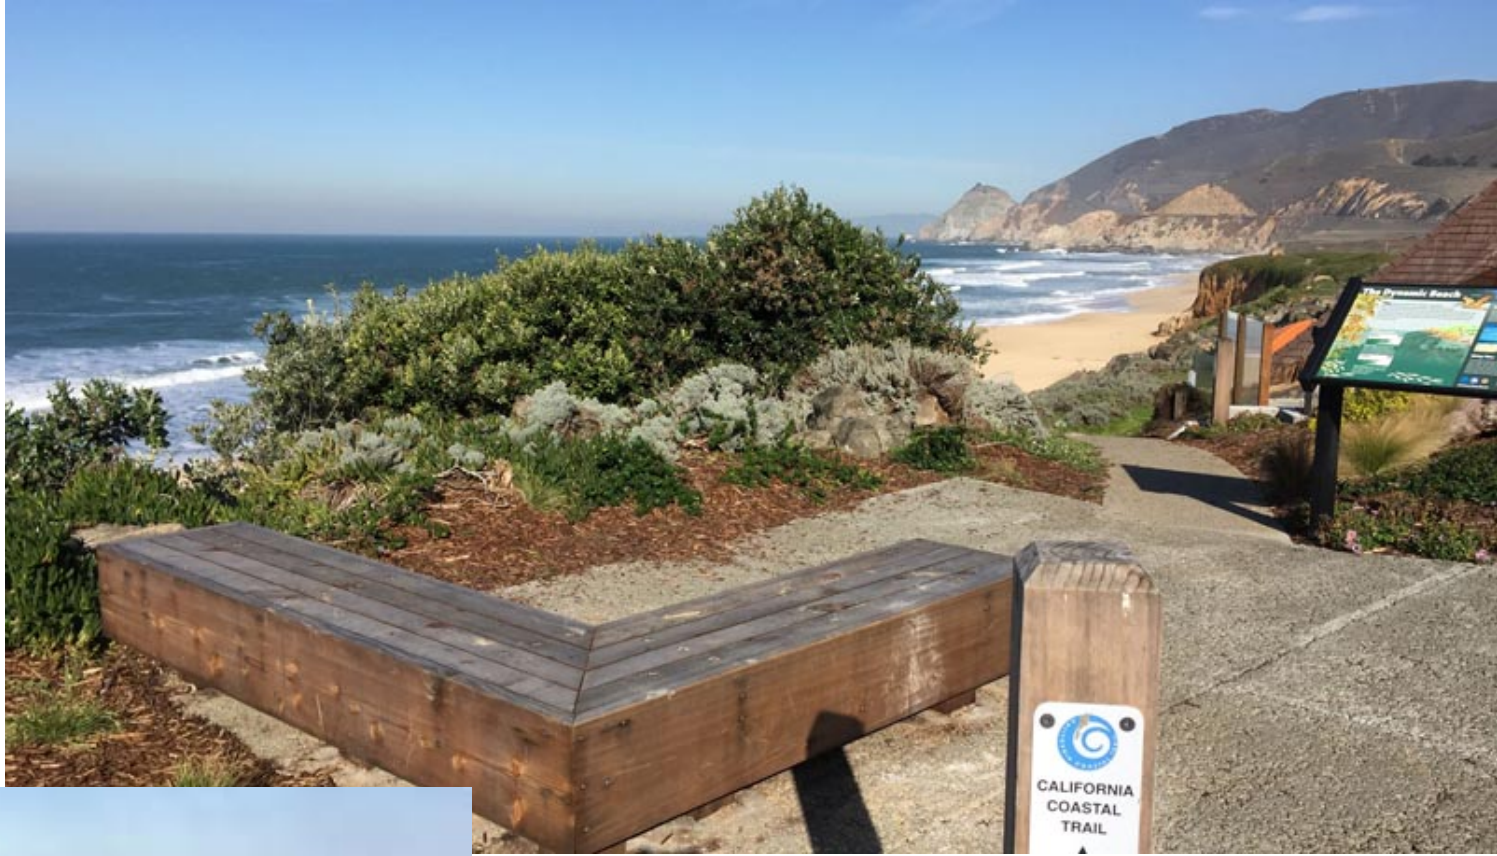
Promontory to the south
hidden from view

Large non-native shrubs invade the rip-rap on State Parks land, blocking the view.

Control of invasive weeds should be included in rip-rap maintenance.
