Coastal Engineering Analysis

West Trail Shoreline Protection, Pillar Point Harbor, CA

Geotechnical Assessment

Pillar Point Harbor West Trail Erosion Repair

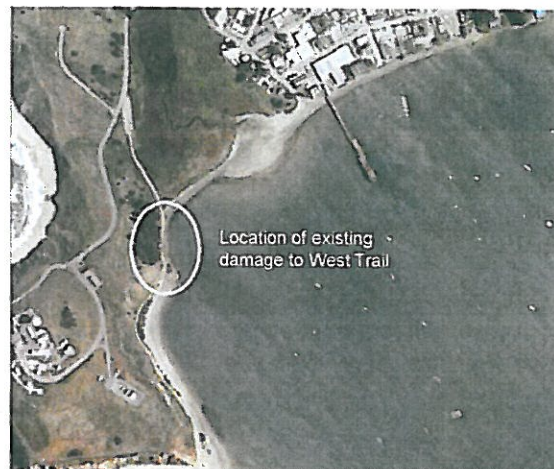
Figure 1. Location of West Trail damage

Coast & Harbor Engineering, Inc. (CHE) was contracted by GHD, Inc. (GHD) to perform coastal engineering analysis and develop design criteria for shoreline protection along the West Trail, Pillar Point Harbor, CA. Figure 1 shows the location of the portion of the West Trail characterized by existing damage (bluff and shoreline erosion). Figure 2 shows pictures of the eroded bluff.

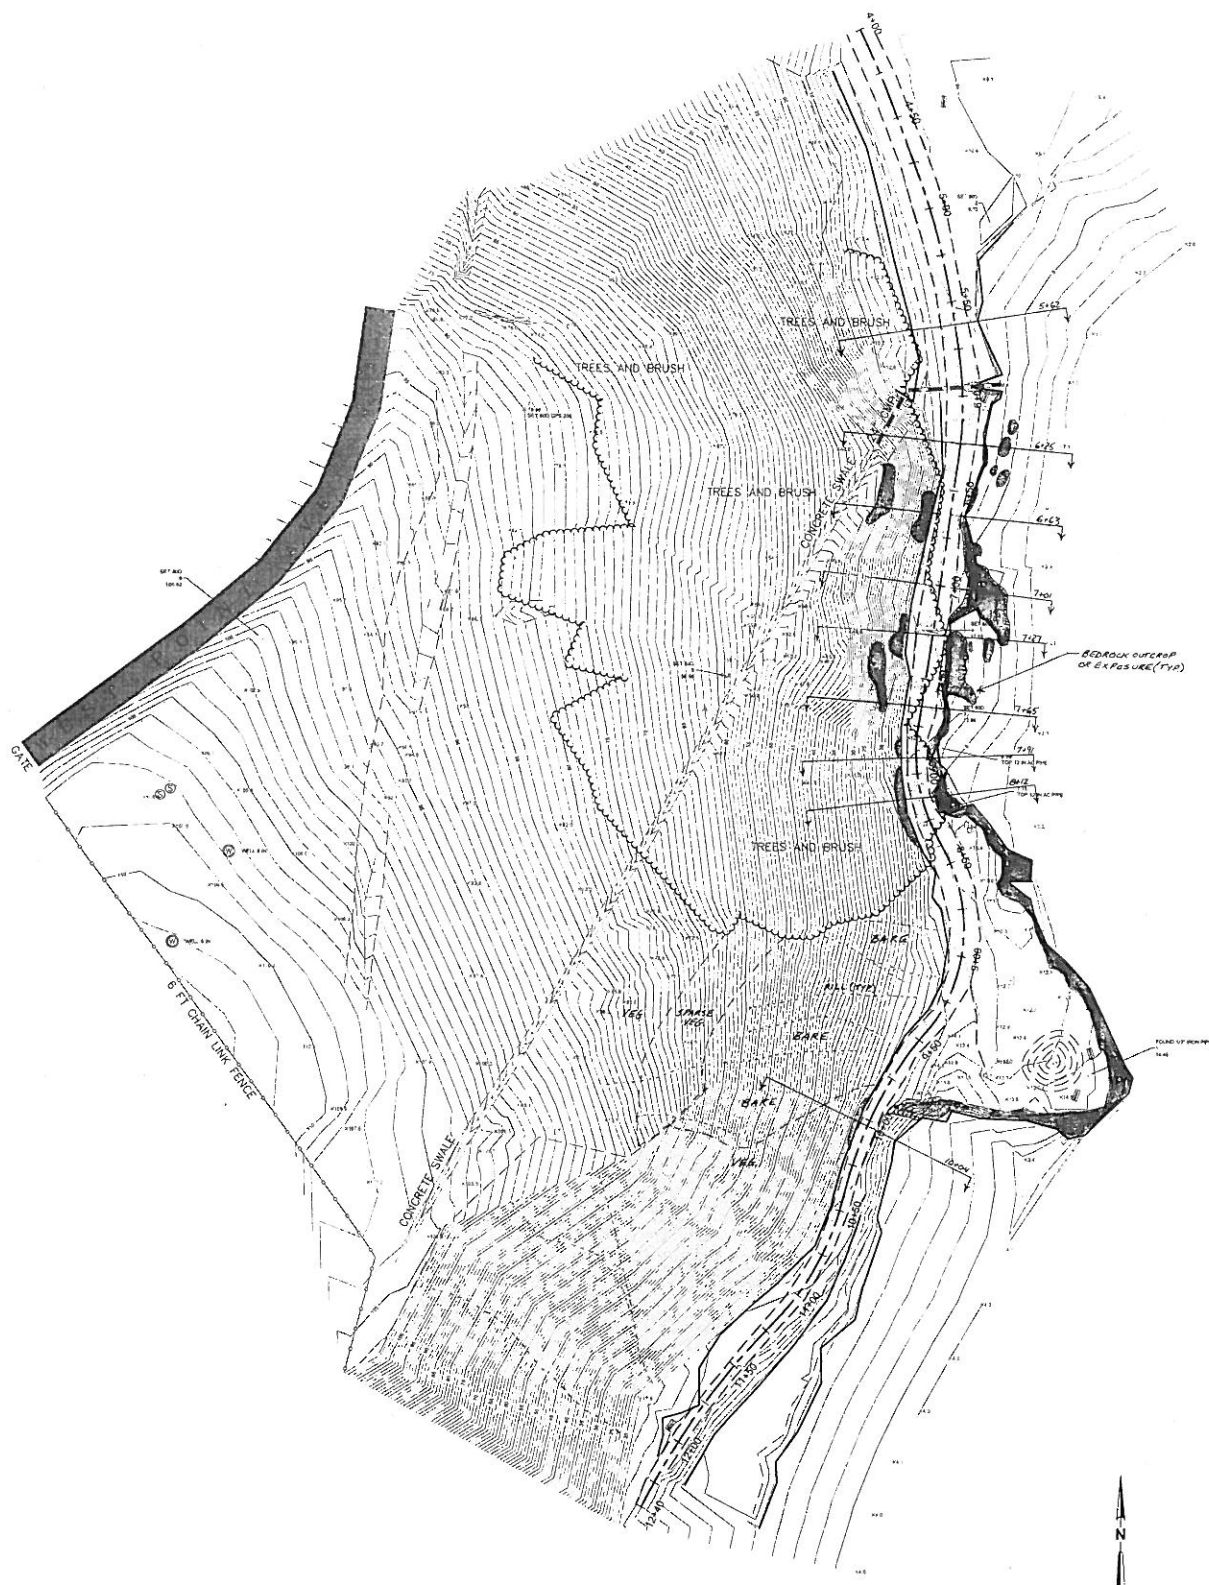
SITE PLAN		
Fisher Geotechnical Civil and Geotechnical Engineering		
PILLAR POINT WEST TRAIL EROSION REPAIR PRINCETON, SAN MATEO CO., CALIFORNIA		
PROJECT NO. 3330	DATE Mar. 2019	FIGURE 1

The west trail and adjoining ridge are underlain at shallow depth by the Pliocene-age Purisima formation bedrock, typically consisting of highly fractured, variably soft to medium hard mudstone, siltstone, and sandstone. Bedrock outcrops and exposures were observed at several locations on the hillside upslope of the trail, in the steep bank adjacent to the trail outer edge, and along the shoreline. Bedrock was also exposed at several locations in cuts in the hillside made for the trail alignment. A limited mapping of bedrock exposures is included on Figure 1. Cross sections showing limited subsurface conditions are shown on Figures 2 through 6.
